**UNDERWATER FACILITIES
INSPECTIONS
AND
ASSESSMENTS
AT

NAVAL WEAPONS STATION

CHARLESTON, SC**

FPO-1-81 (7)

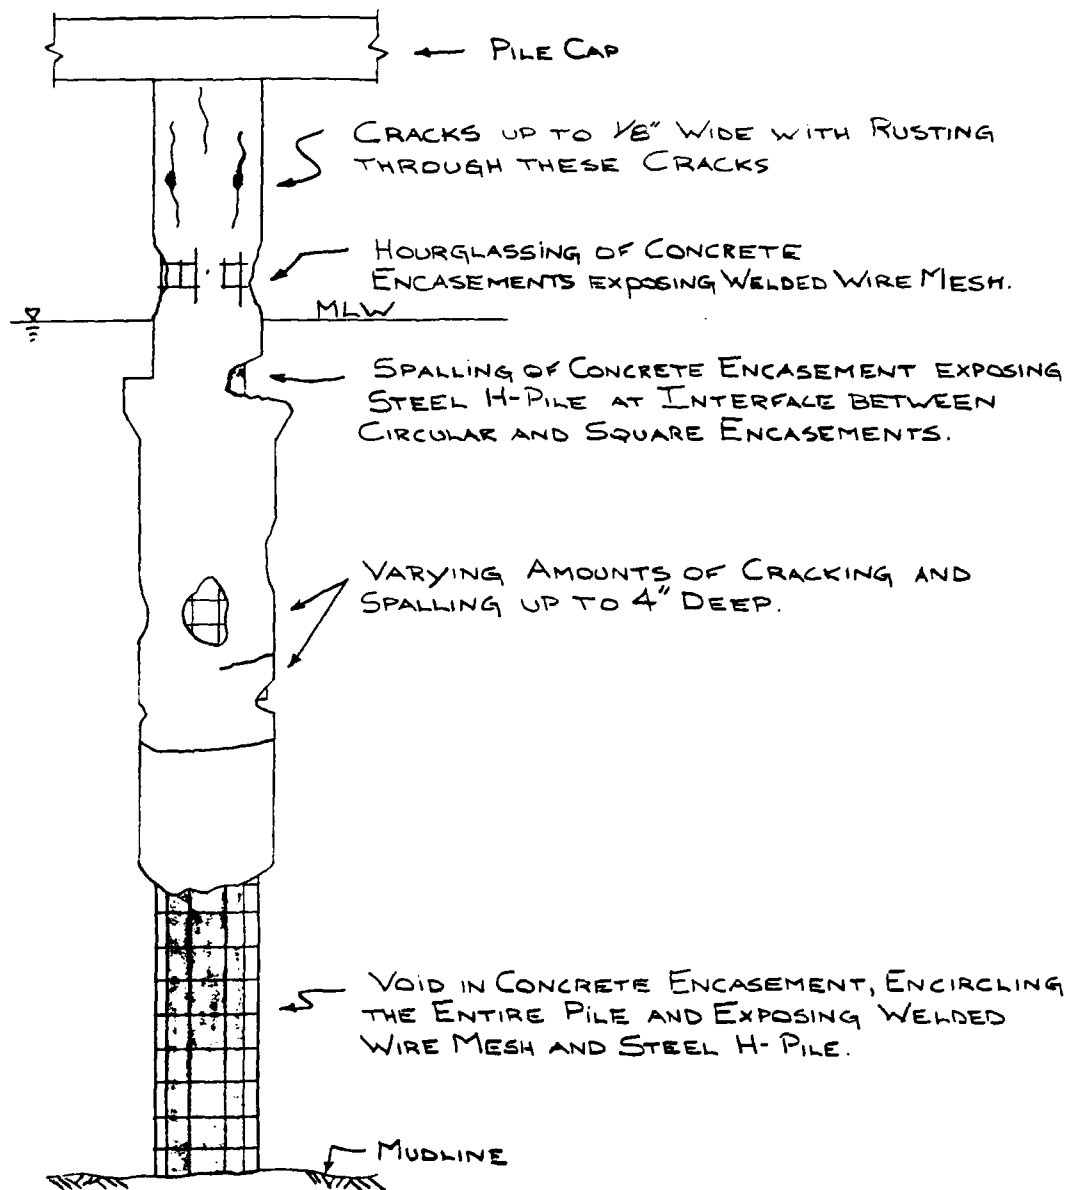
TYPICAL PILE CONDITIONS

Figure 9 shows a composite of typical pile conditions found at Pier BRAVO.

All the concrete encasements on the steel H-piles of Pier BRAVO show varying amounts of deterioration, and in many places, the encasements are not protecting the piles from salt water corrosion. Steel thickness measurements indicate that in some areas up to 50% of the steel has been lost due to corrosion. However, based on structural analysis calculations, the pile foundation can still handle the imposed loads (see Appendix).

No repairs are recommended for Pier BRAVO at this time. However, Pier BRAVO should be reinspected in three years to document any further deterioration. This report should be used as a baseline for this future inspection.
